GAYTON DRAINAGE ISSUES

JAN/FEB 2021

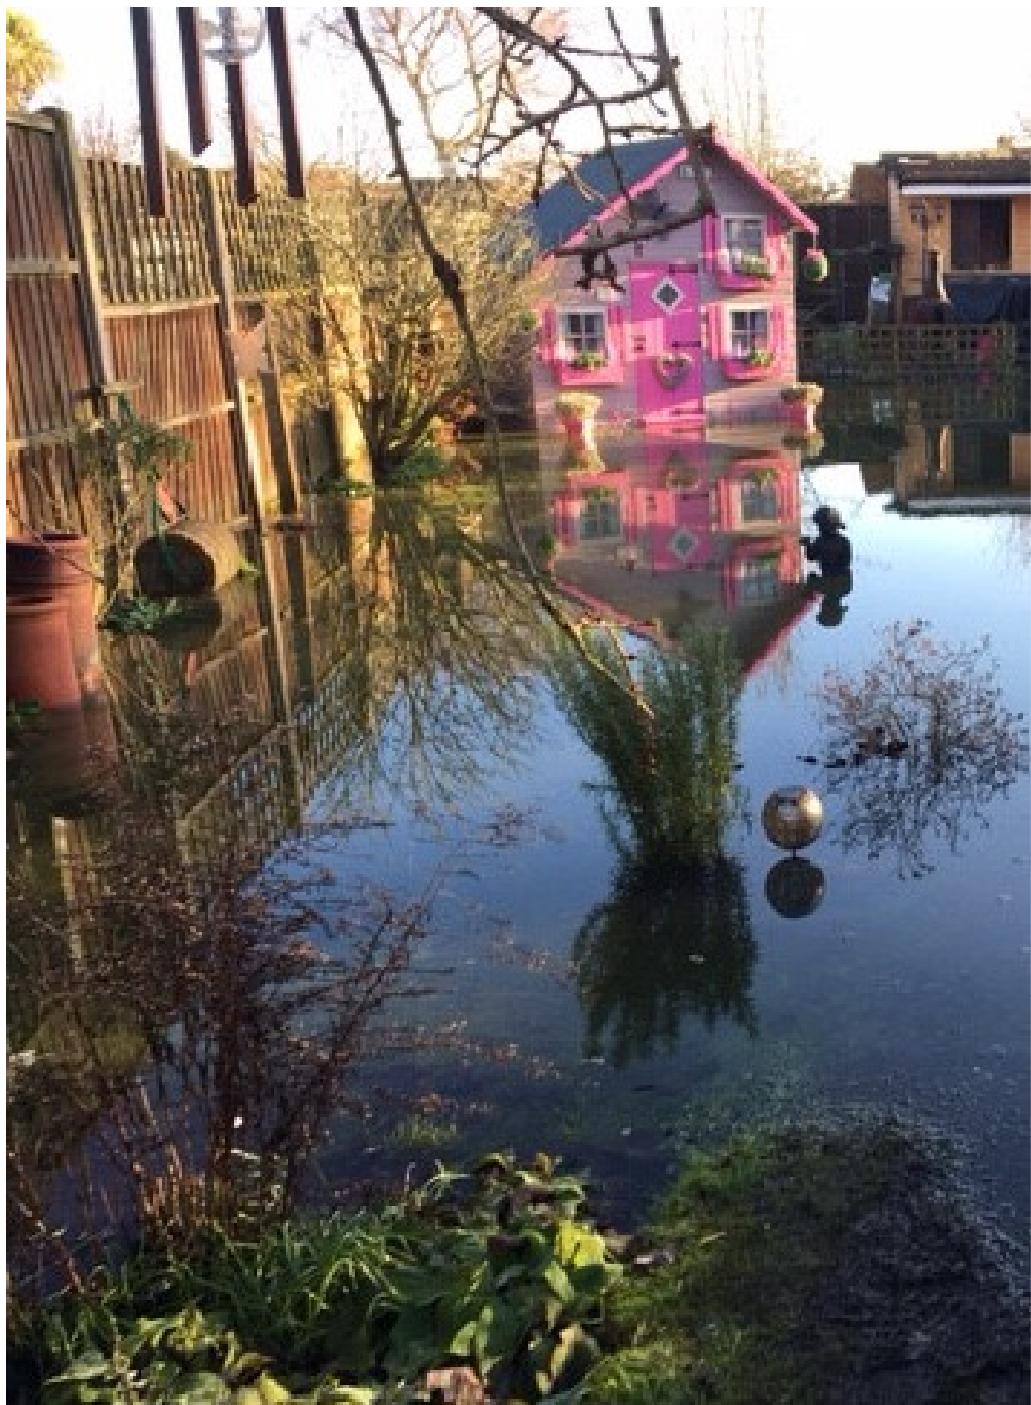
Flooded garden on Winch Road as photographed 17-01-21
(flood water seemed to be 100% surface water & no sewage).

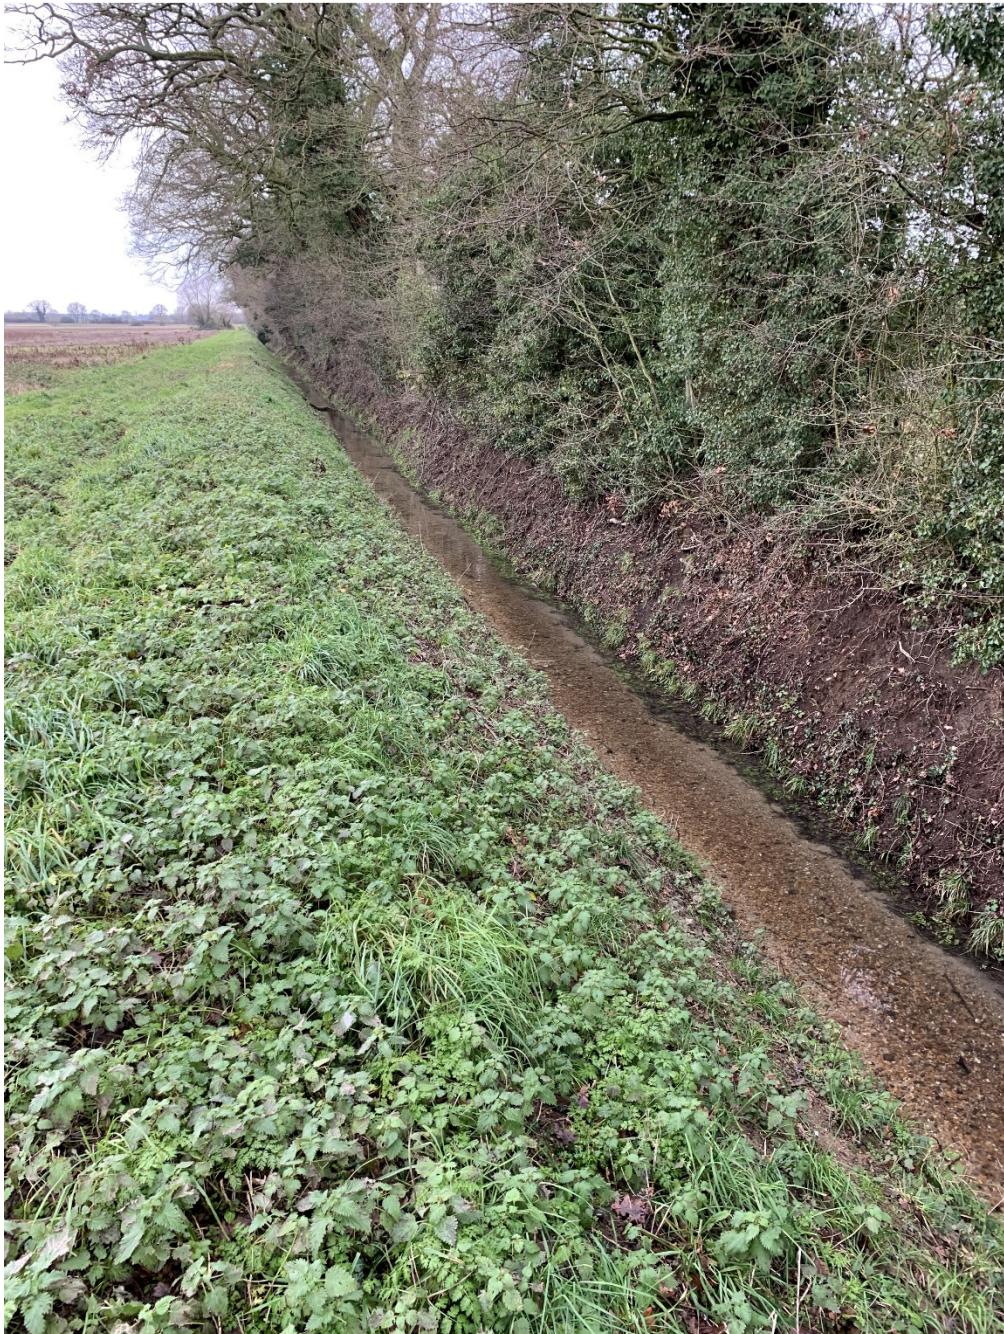
On 18-01-21 whilst the Winch Road garden was flooded as shown on the previous photograph, this is the main surface water ditch that takes surface water from Back Street, Winch Road and Springvale. It runs roughly due west from the village and starts near the sewage pumping station where the underground surface water pipe crosses Winch Road and discharges at the top of this ditch (just out of shot nearest the camera).

The ditch is maintained by King's Lynn Internal Drainage Board and as can be seen, is very clean and well maintained. The fact that the ditch is running freely with masses of capacity and the outfall is not running anything close to full bore indicates that there may be a problem with the village surface water system. This could be unrelated to the school site discharging into that system. The pump used appears to have been a sludge pump the rubber diaphragms of which allow sludge, slurry and solids up to 40mm or so (depending upon spec), to be pumped. (Update of 03-2-21 – the site manager has assured Gayton PC clerk Sarah Bristow that they would not have caused an issue).

Nevertheless, this is not a finger pointing exercise and it is readily accepted that it may not be the school discharge, but given the village has not previously experienced the sort of surface water flooding seen recently, it is worth investigating.

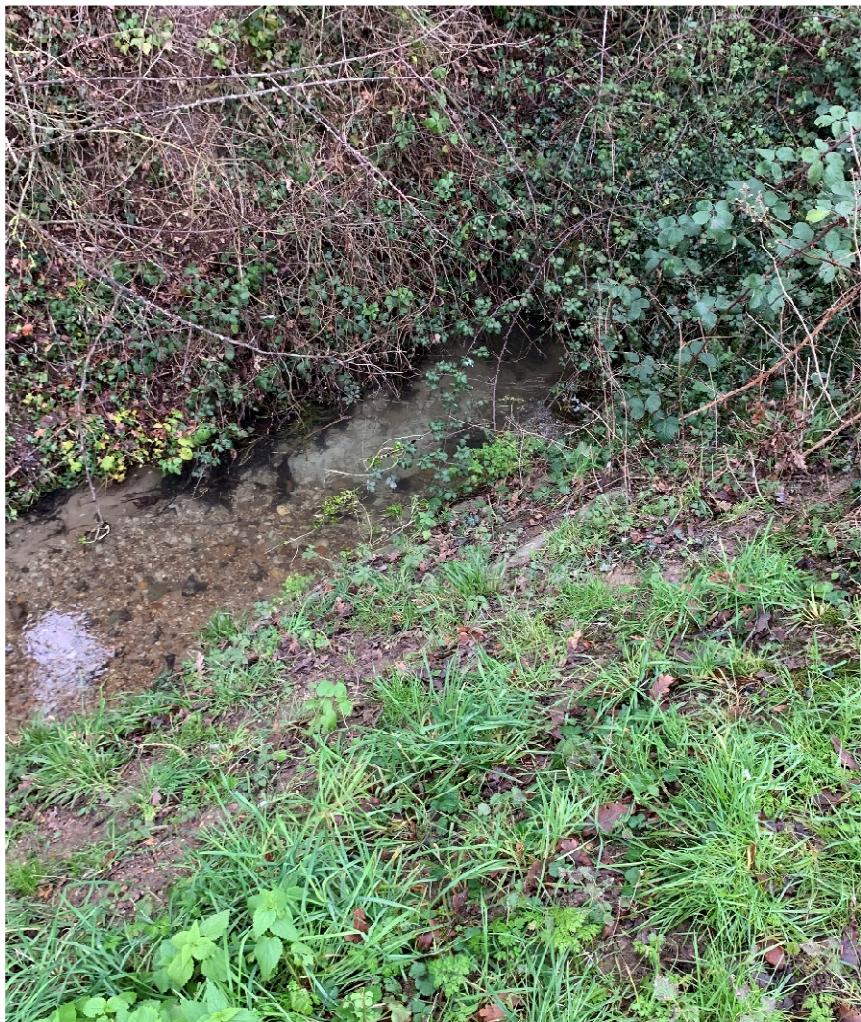
Winch Road and shows the water as it discharges into the underground pipe and away to the ditch on the previous photo. Again, this ditch is maintained by King's Lynn Internal Drainage Board and as can be seen is clean and well maintained and has masses of spare capacity.

This is the overflow of the main ditch taking water from Gayton Hall parallel with Back Street and out under the road culvert on Winch Road as you head south out of the village towards East Winch. This photo is taken near the junction of Back Street and

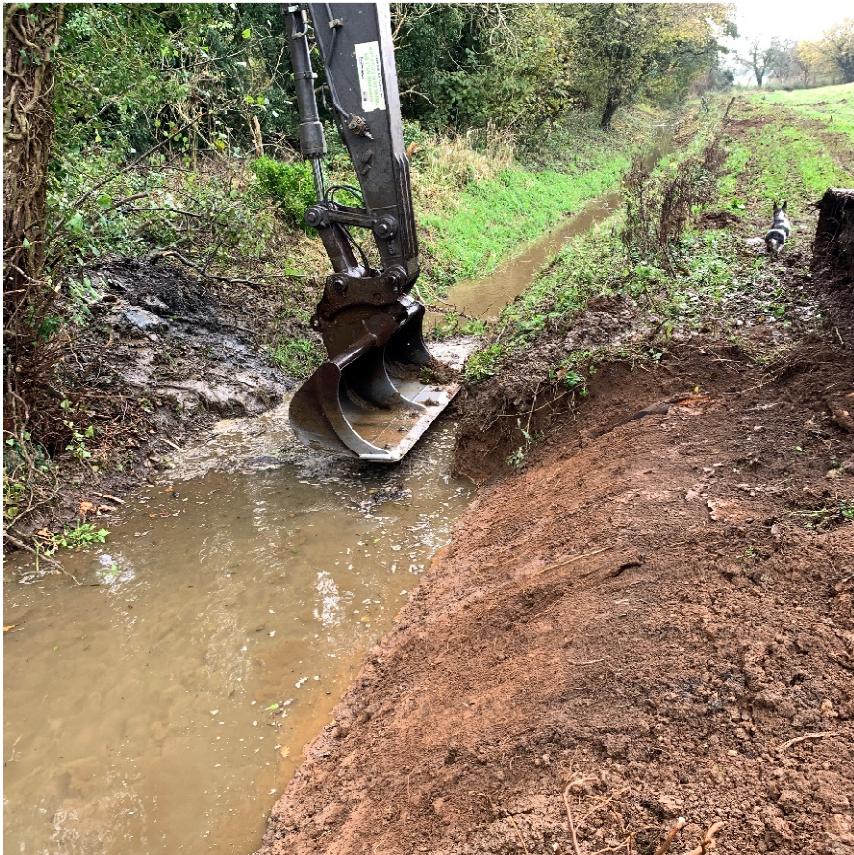
The above shows drainage ditches to the west of the village draining Acorn Drive and Lynn Road being cleaned out on 10th November 2020 by Gayton Estate. The amount of silt removal and widening of the channel is clear to see.

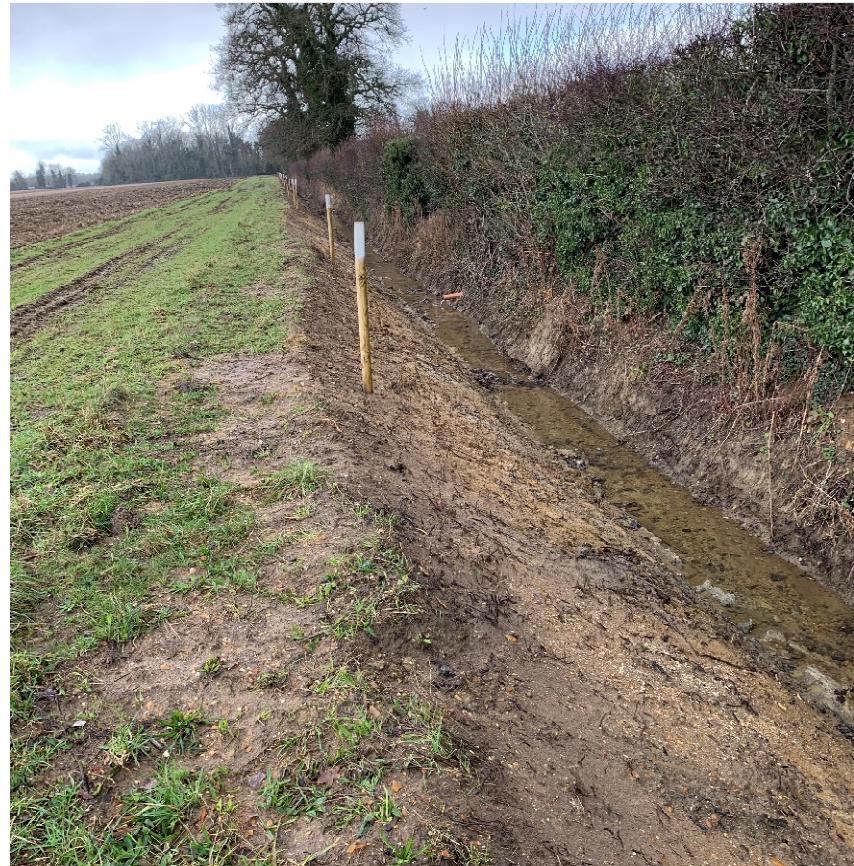
The above shows the same ditch post cleaning on 4th January 2021 (the wood in the distance is the one the digger is working alongside in the previous photo).

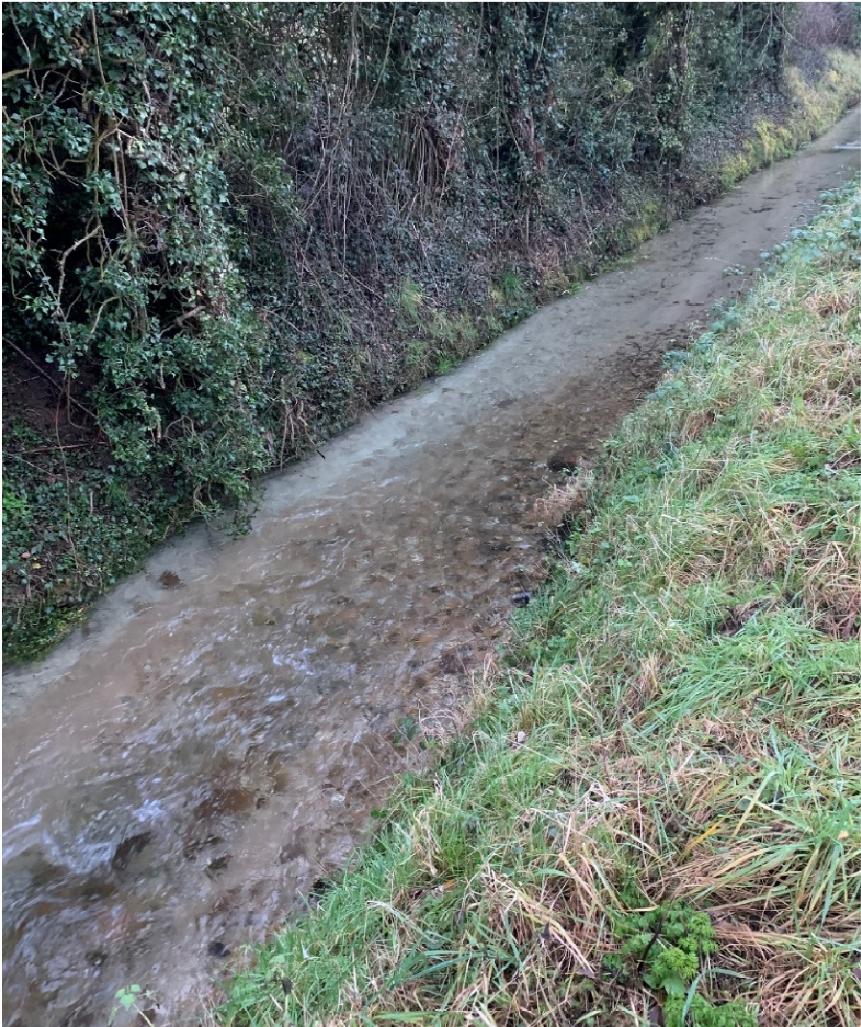
Photo opposite, taken 02-02-21 shows the ditch running from Gayton Hall to the Winch Road culvert. Again, the ditch is maintained by King's Lynn Internal Drainage Board, it is clean and well maintained and has a lot of spare capacity.

Photos appear to show that the surface water system is working well and KLIDB and private landowners are doing a good job in

maintaining waterways. What appears to be the problem (in terms of surface water drainage), is that water is not able to discharge quickly enough into ditches to drain the village (primarily from Winch Road/Springvale area it seems). A matter to discuss & investigate with NCC Highways and Anglian Water.
