# Gayton and Gayton Thorpe Neighbourhood Plan

## Appendix B

## Appendix B Non-Designated Heritage Assets

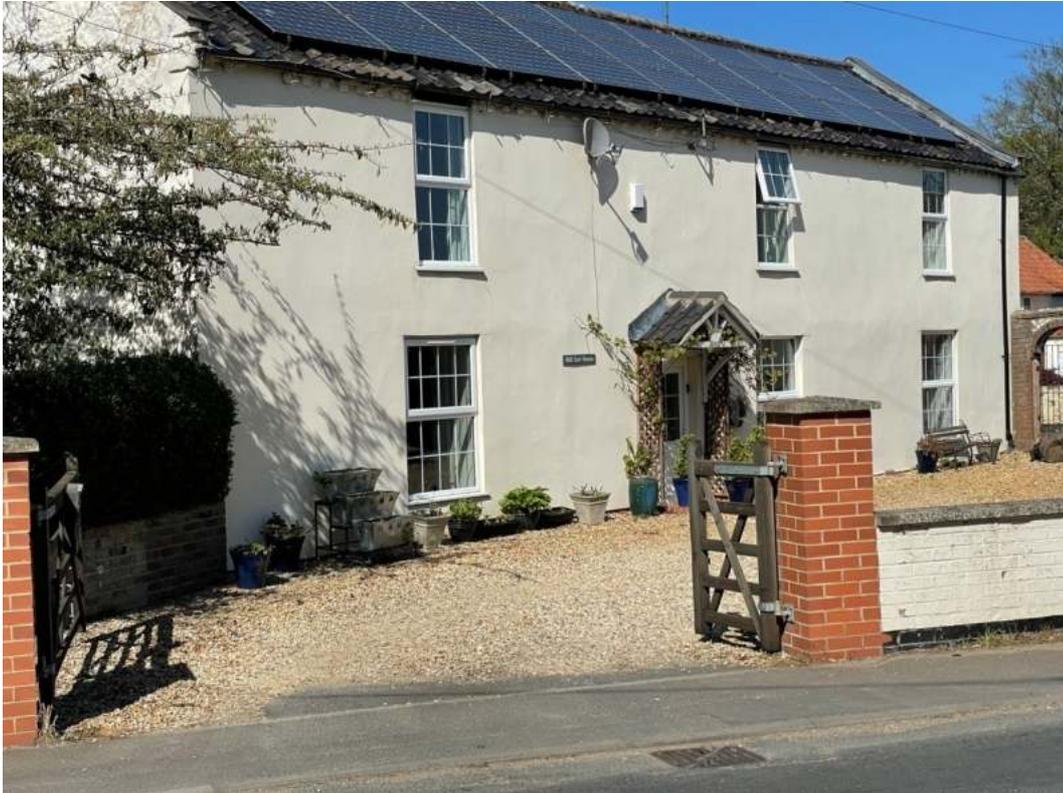
Figure 41: Mill End House, Lynn Rd -B1145/Grimston Rd -B1153

**Description:** White Norfolk brick, flint and chalk property with pantile roof, circa 1840-1914

**Significance:** Of local historic interest and association. Having a valued past life and association with the once thriving Milling industry in Gayton.

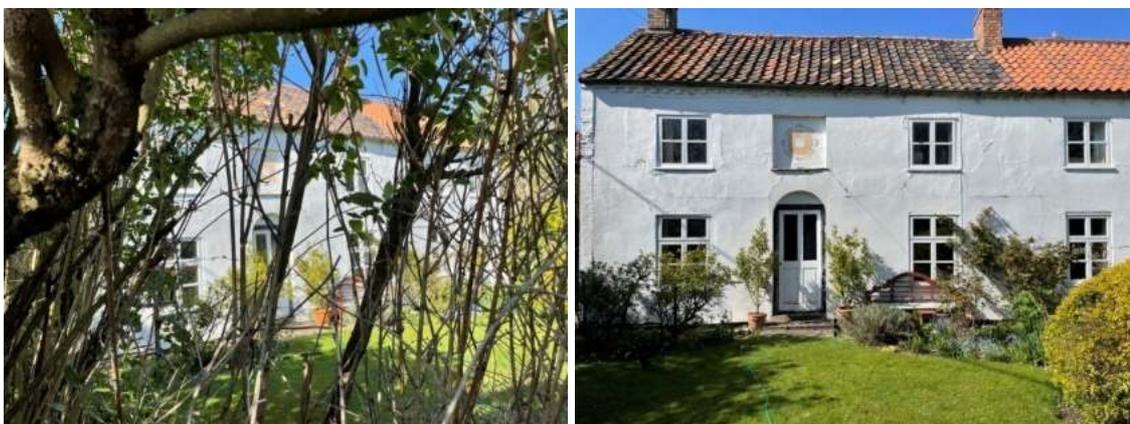
Figure 42: Rose Cottage, Lynn Road/Orchard Rd, circa 1820-1840.

**Description:** Lime washed brick, flint and chalk property with Norfolk pantile roof and surrounding flint wall.

**Significance:** In a landmark position and of architectural and aesthetic value being a distinctive looking cottage with large Tudor Rose painted emblem in red and blue on front facing wall.

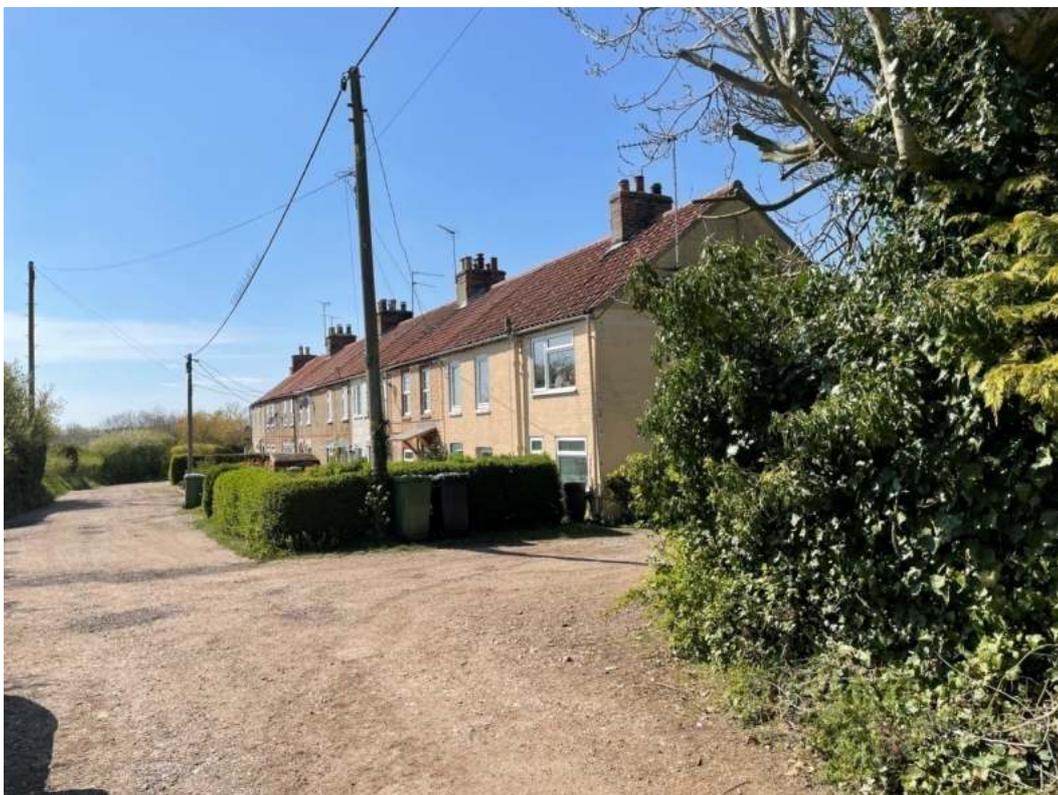
Figure 43: Ebenezer Cottages. Lime Kiln Rd, circa 1840-1914

**Description:** Row of workers cottages built of brick and flint with Norfolk pantile roofs.

**Significance:** Of local interest due to having a valued past life as housing for the workers at the lime/chalk quarry.

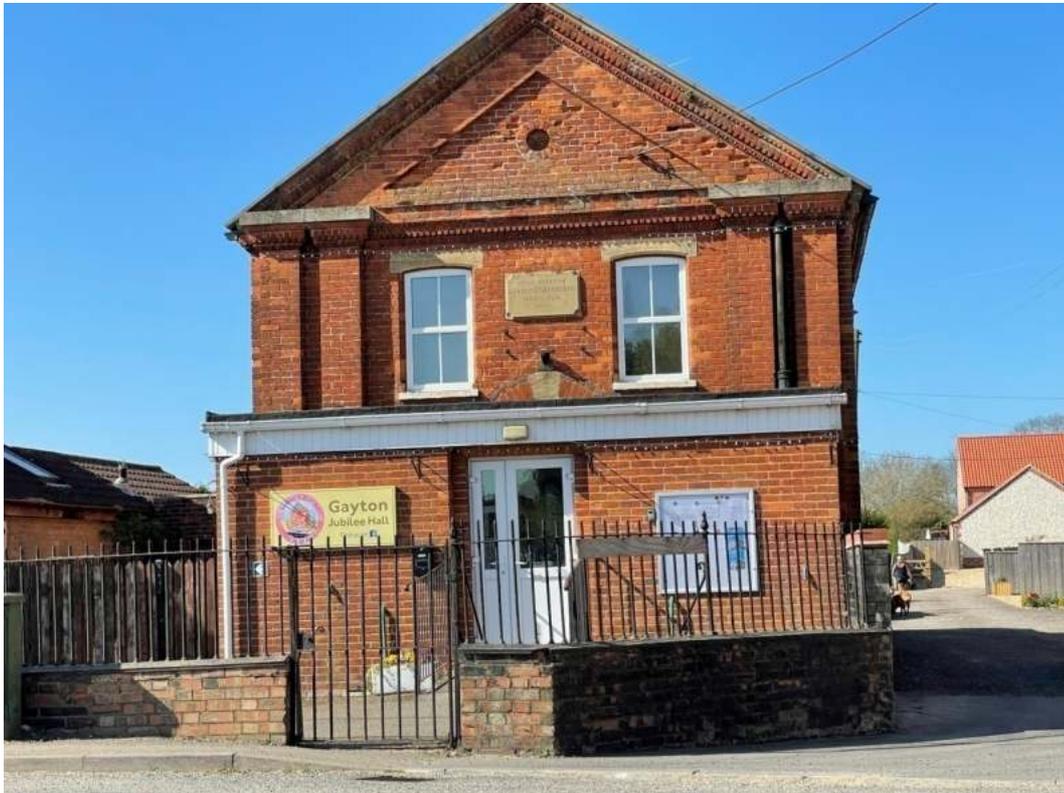
Figure 44: Jubilee Hall, Lynn Rd, circa late 1800's

**Description:** Gayton Village Hall former 'Friends in Need Lodge,' built late 1800's, (stone inset 1887) red brick with slate roof. Front and rear amenity additions made 1900's. Sited on corner of Lynn Rd/B1145 and Jubilee Lane.

**Significance:** A building of local historic interest and association that is reasonably unaltered and the style, form and construction of the building is easily identifiable.

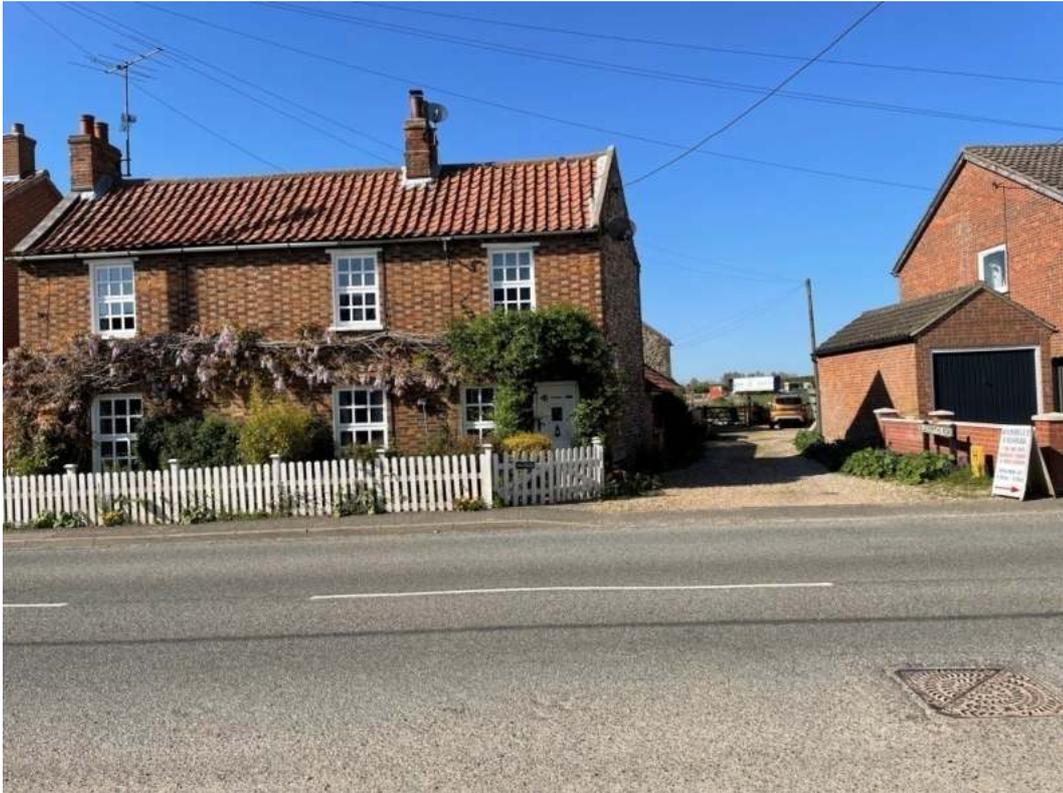
Figure 45: The Old Smithy, Lynn Road and Blacksmiths Row, circa mid 1800's

**Description:** Red brick triple fronted house with pantile roof and clapboard fencing to front. Side elevations are of flint construction. Property originally three separate one down—one up cottages with a stable and blacksmiths attached to the cottage bordering Blacksmiths Row. Older parts of property are judged to have been built around 1800.

**Significance:** Of local historic interest and association. The building is largely unaltered and its style, form and construction is easily identifiable.

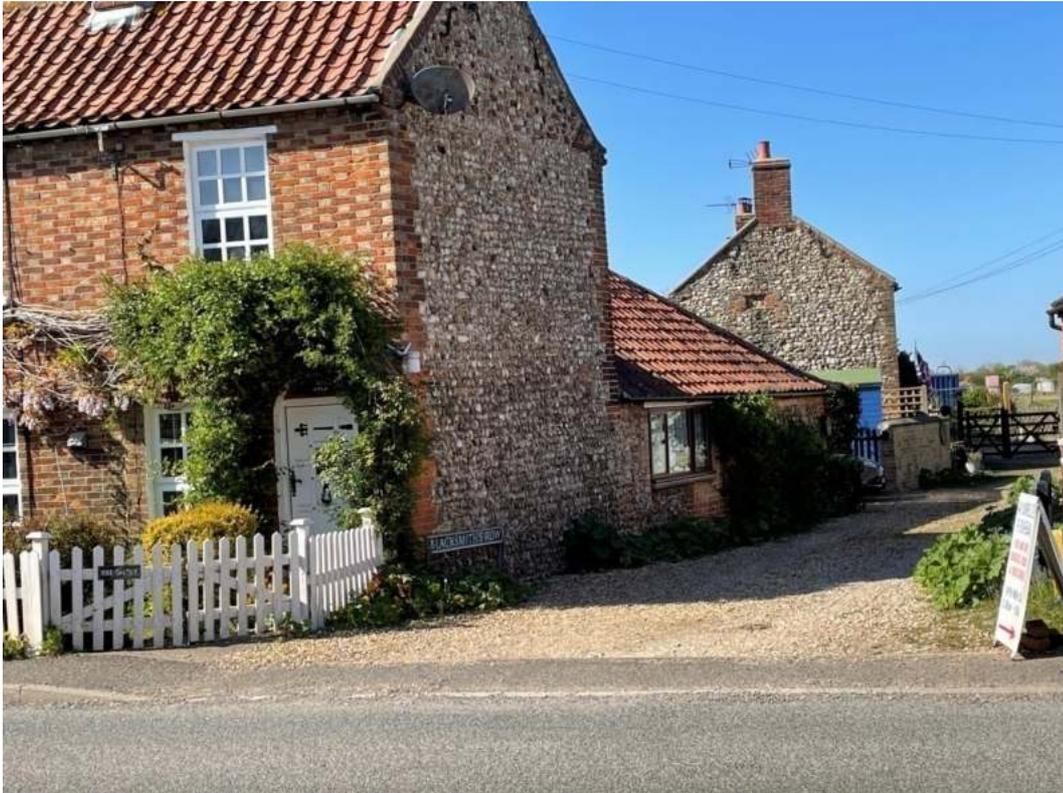
Figure 46: Row of Classic Terraced Cottages at Blacksmiths Row and at rear of The Old Smithy, circa mid 1800's

**Description:** Red brick and Flint construction with pantile roofs.

**Significance:** Of local historic interest and association. A surviving row of workers cottages overlooking a chalk-built outhouse and horse paddock. The form and construction of the buildings is easily identifiable.

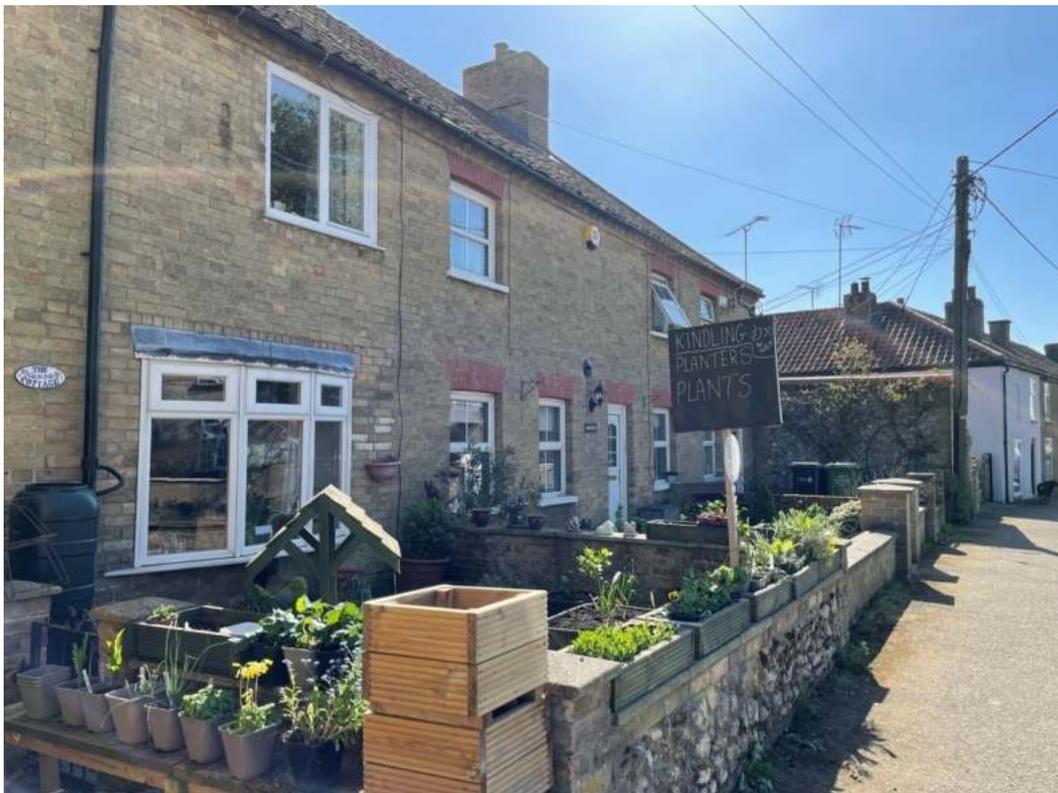
Figure 47: Row of Classic Terraced Cottages, Lynn Road, circa late 1800's. Situated opposite the Old Doctors house dated 1880.

**Description:** 'The Cottage'/'Mabeldene' etc Yellow brick built construction with red brick decoration and pantile roofs.

**Significance:** Of local historic interest. Formerly known locally as 'Robert Hill Cottages' sited along the south boundary of Lynn Road. The cottages are largely unaltered and the style, form and construction is easily identifiable.

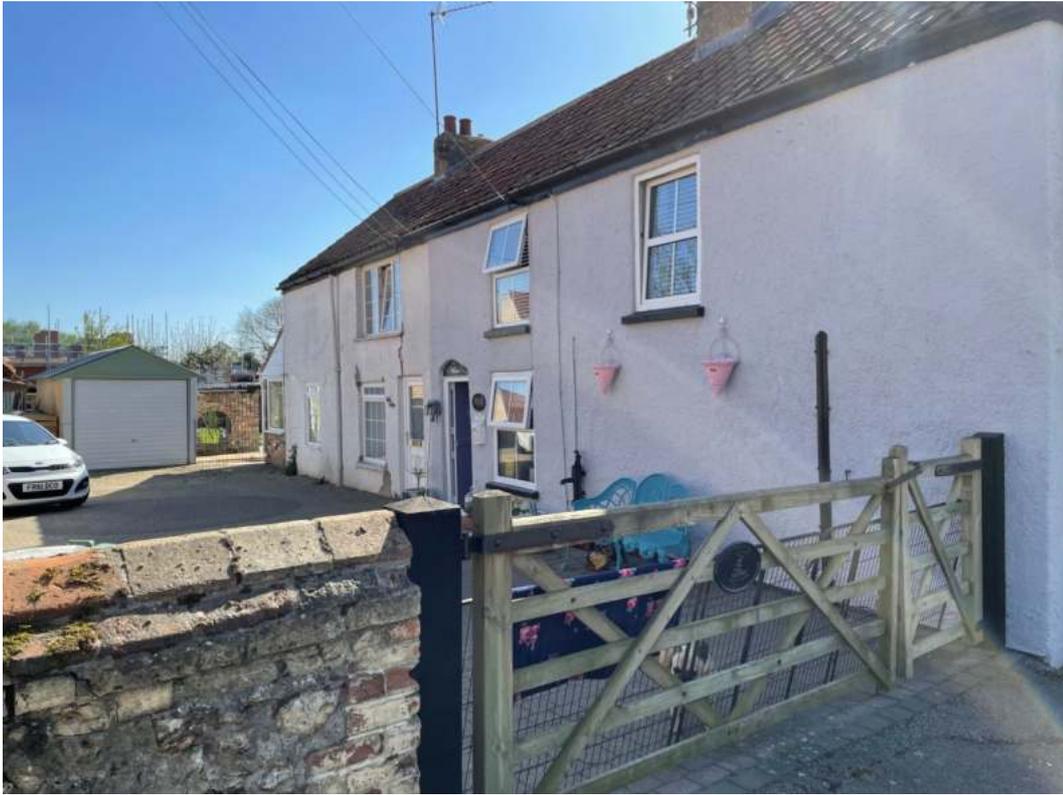
Figure 48: Pump Yard, Lynn Road, circa late 1700's

**Description:** Modern render covered brick and clunch cottage (appears to be several cottages now forming one residence) with pantile roof. Side facing Lynn Road.

**Significance:** Of local historic interest and association. Was known to be a watering hole and wash house for the drovers who would stop here before taking their sheep through the attached land, across to Back Street on the south side of Gayton village. The building is largely unaltered, except for an extension to the rear and the style and form is easily identifiable.

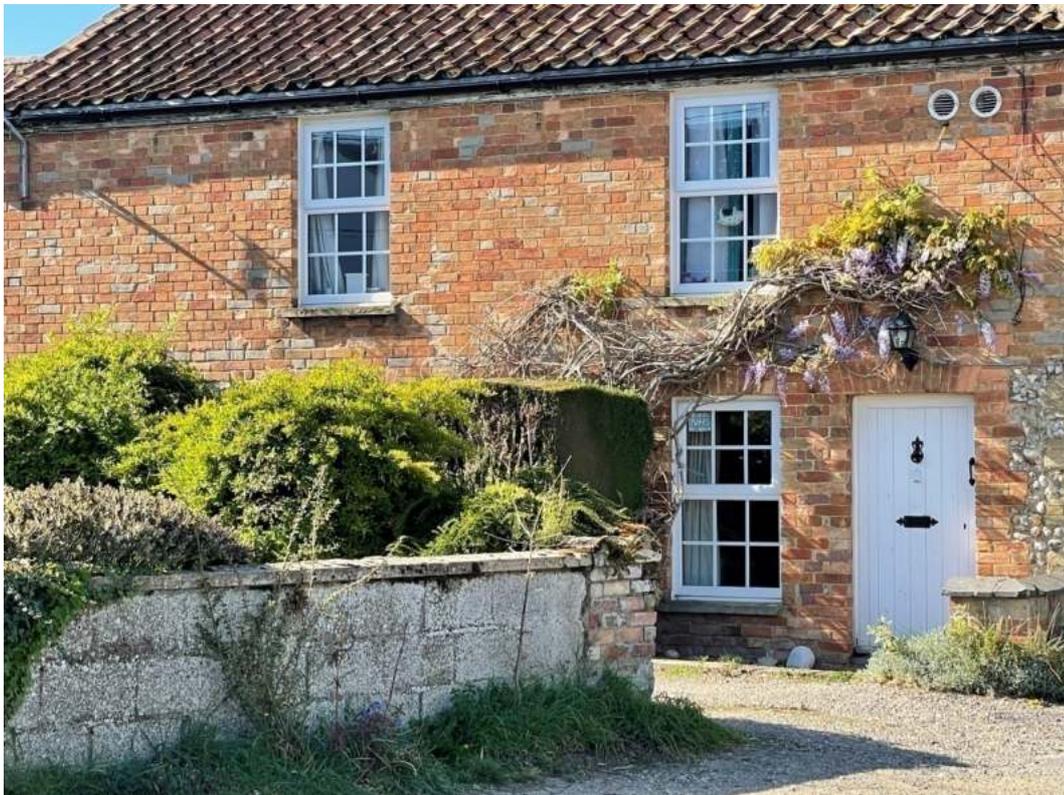
Figure 49: Pelham House, Winch Road, circa 1800's

**Description:** Red brick dwelling with flint and brick gable ends, pantile roof and rear extension. Side facing onto Winch Road

**Significance:** Of local historic interest. It is a vernacular house contributing to the character of the northern end of Winch Road.

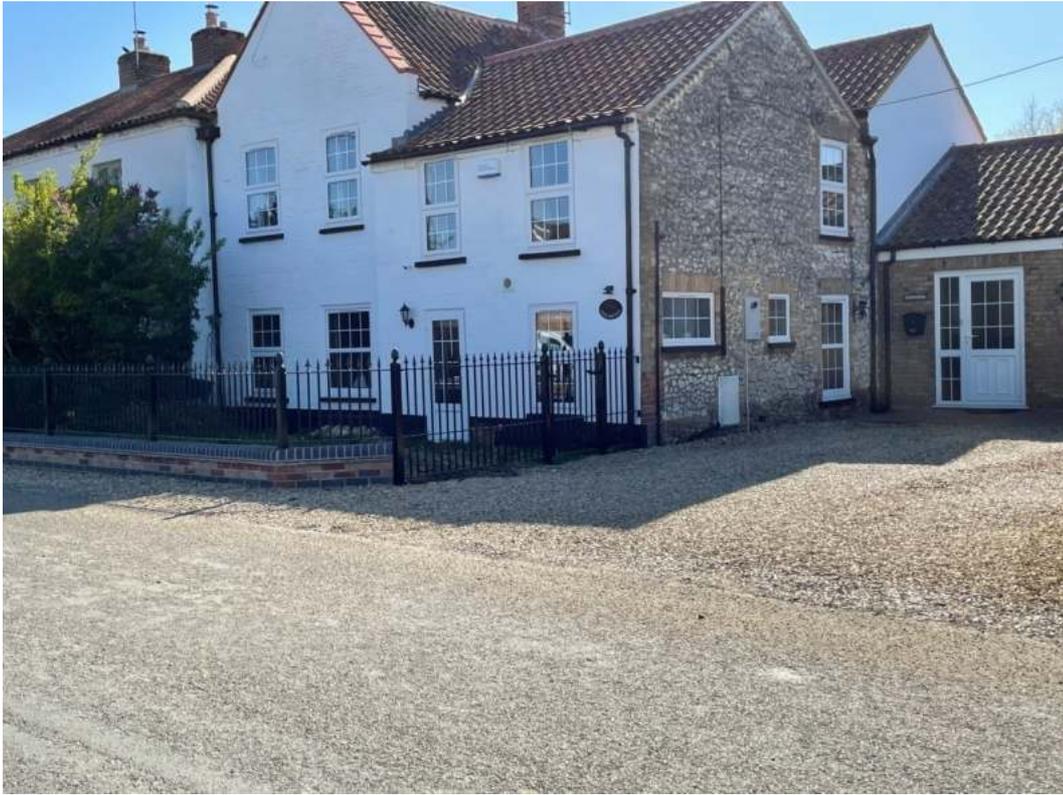
Figure 50: Oakdene, Winch Road, circa mid to late 1800's

**Description:** Brick, chalk and flint dwelling, with pantile roof and several extensions, recently renovated.

**Significance:** Of local historic interest. It is a vernacular house contributing to the character of Winch Road.

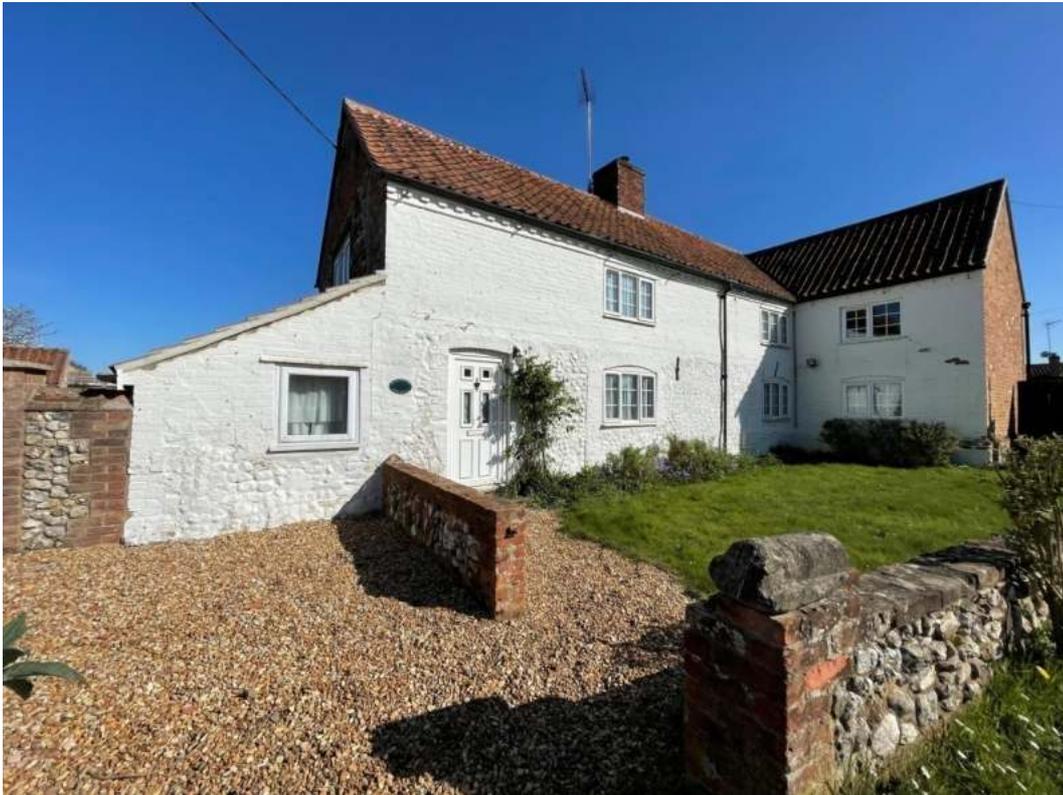
Figure 51: Rosemary Cottage, Rosemary Lane, circa early 1800's

**Description:** Built of brick, chalk and flint with gable ends mainly of carrstone, with pantile roof and side extensions.

**Significance:** Of local historic interest and association. It is a vernacular house that is reasonably unaltered and the style, form and construction of the building is easily identifiable.

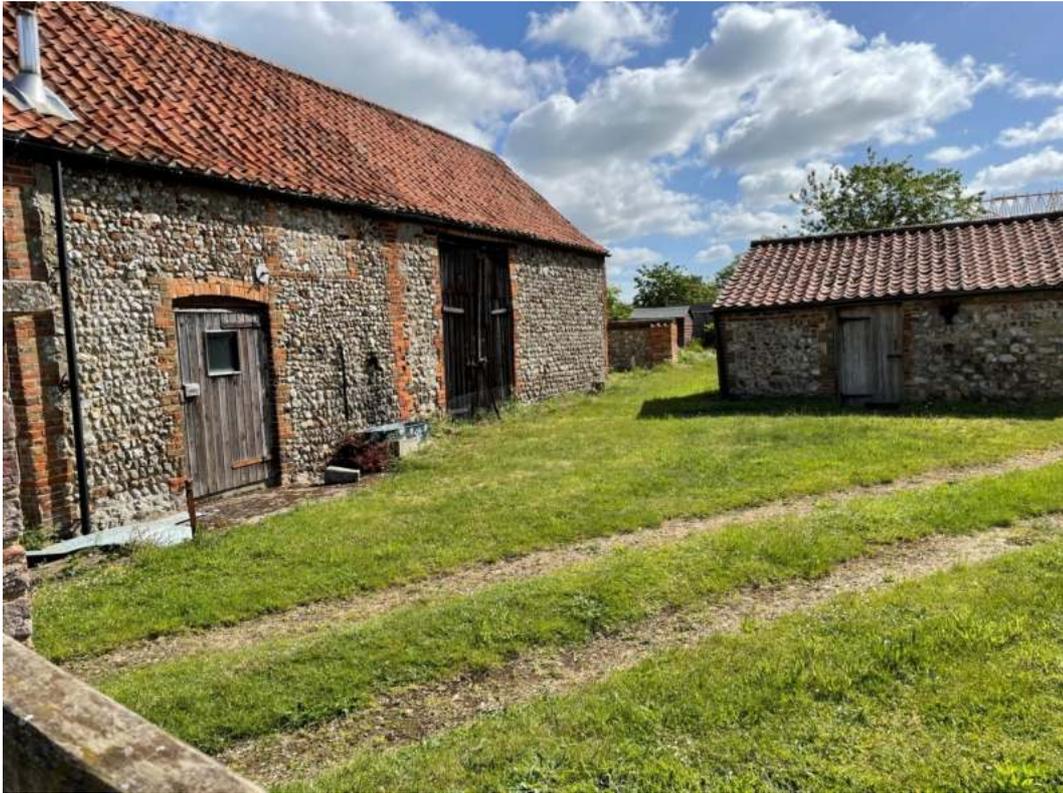
Figure 52: Barns to Rosemary Cottage, Rosemary Lane, circa early 1800's

**Description:** Both barns are built of chalk and flint with brick inclusions. Pantile roofs, oak doors and frames.

**Significance:** Of local historic interest and association. They are good examples of smallholders Barns, once common in the area. The style, form and construction of the buildings is easily identifiable.

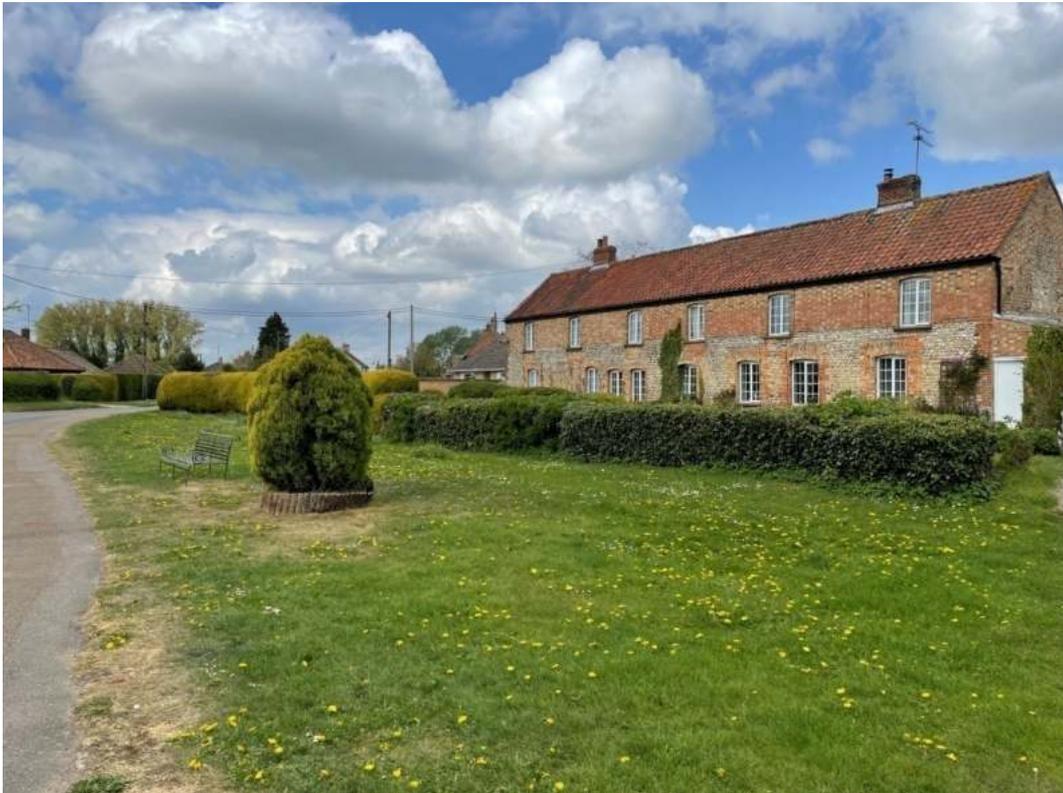
Figure 53: Church Cottages, Back Street circa late 1800's

**Description:** Red brick and flint built terrace of workers cottages with pantile roof and later additions of small extensions to side and rear.

**Significance:** Of local historic interest and association. It is the only example of a terrace of workers cottages fronting Back Street, which once would have been common in Gayton. The style, form and construction of the buildings is easily identifiable.

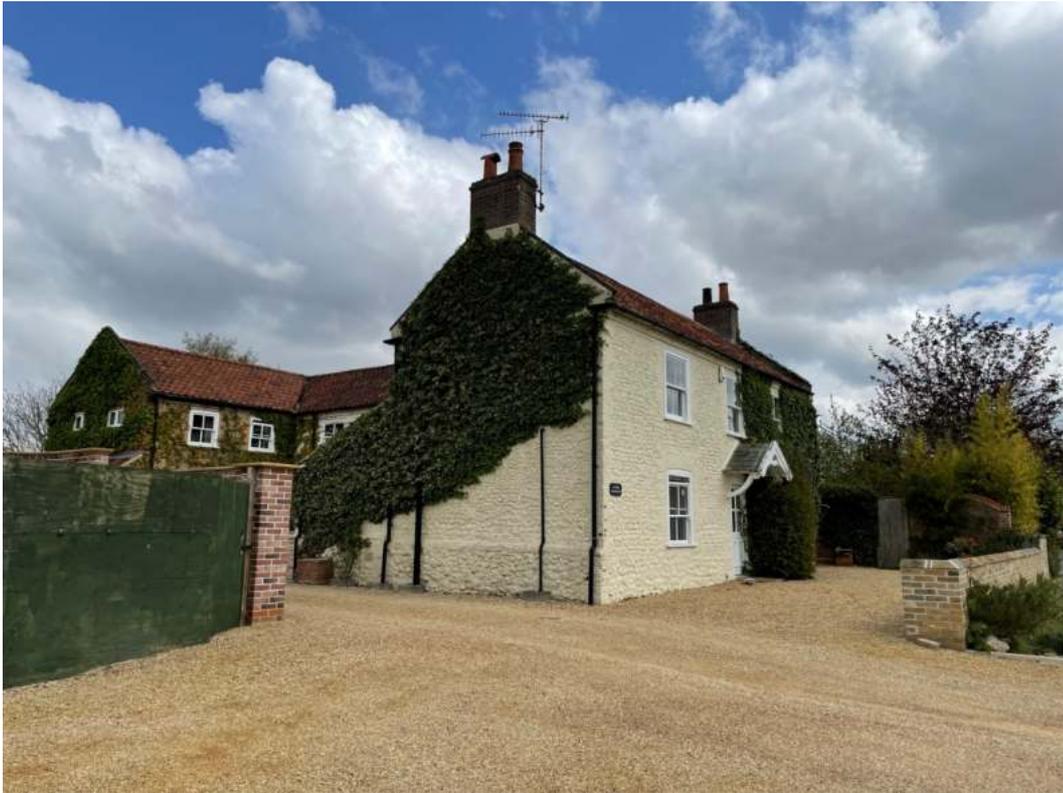
**Figure 54: Manor Farmhouse, Back Street late 1700's – 1800**

**Description:** The frontage is mostly chalk lump (clunch in the vernacular) with the single storey northern end being flint outside and chalk inside. The smaller barn to the west is carrstone and brick and is thought to be the oldest building on the site. The whole house and barn were fully renovated in 2000 with UPVC sash windows replaced with timber, original buff pantiles sourced and used and chalk walls in what is now the drawing room, renovated solely with existing materials from the site. A further significant extension was added in 2005.

**Significance:** Of local historic interest and association. It is a distinctive vernacular house, in a prominent landmark position, contributing to the rural community of Back Street. The style, form and construction of the building is easily identifiable.

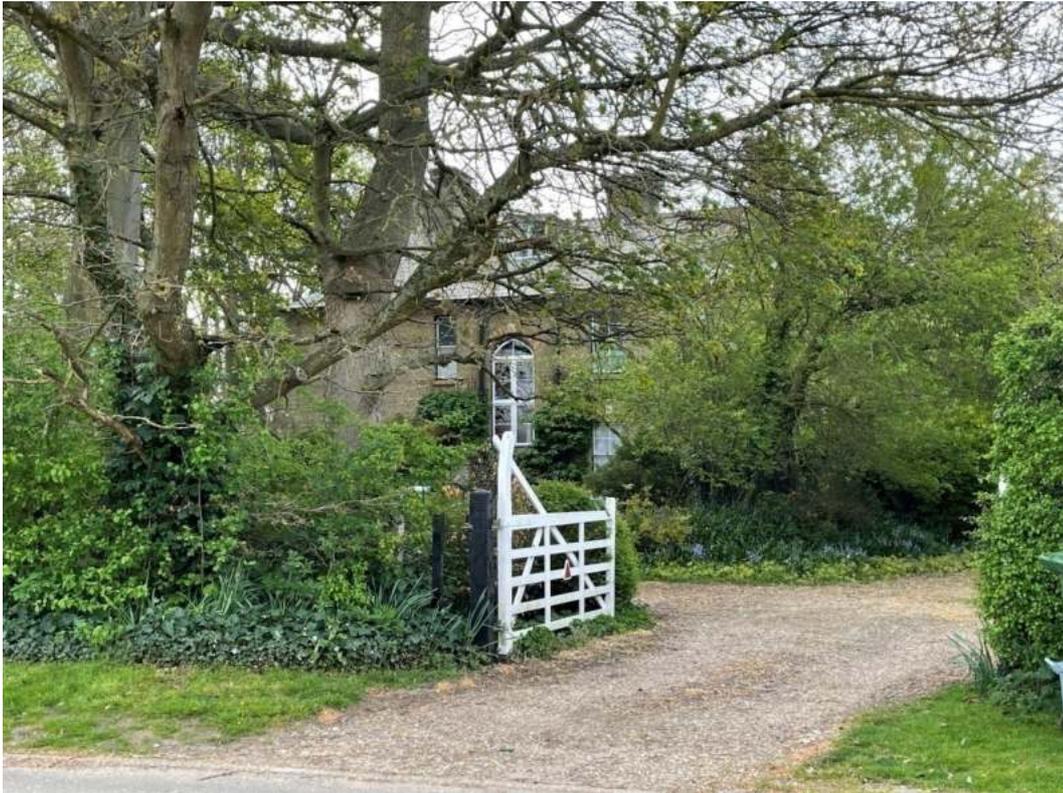
**Figure 55: The Old Vicarage, Vicarage Lane, Lynn Road circa 1800's**

**Description:** Former vicarage, built from yellow brick with slate roof and architecturally distinctive double height front facing window. The property is now a private dwelling.

**Significance:** Of local historic interest and association and can be identified as a Landmark. The building appears largely unaltered and the style, form and construction of the building is easily identifiable.

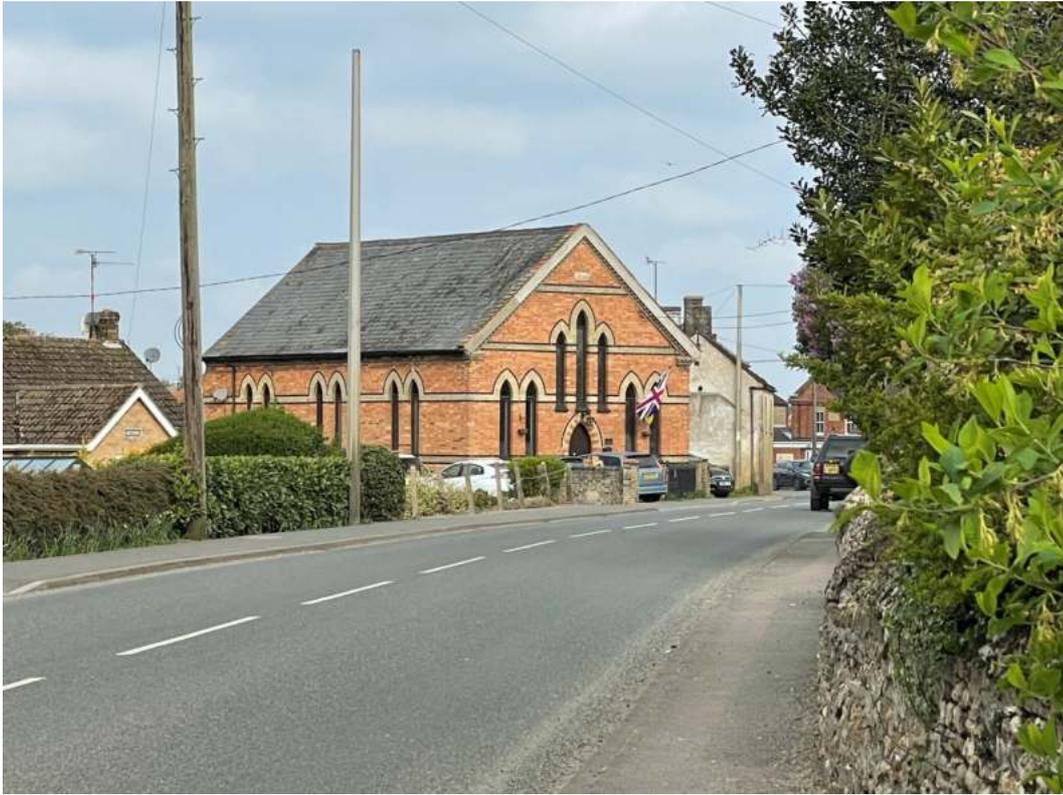
Figure 56: The Old Chapel, Lynn Road circa 1870

**Description:** Former Primitive Methodist Chapel built from red brick with distinctive yellow brick decoration around the arched windows and slate roof. It was extended in 1883. The Chapel was sold in 2015 and converted to a private dwelling.

**Significance:** A building of local historic interest and association that is reasonably unaltered and the style, form and construction of the building is easily identifiable. The property sits in a landmark position and can be seen by all who travel along the B1145.

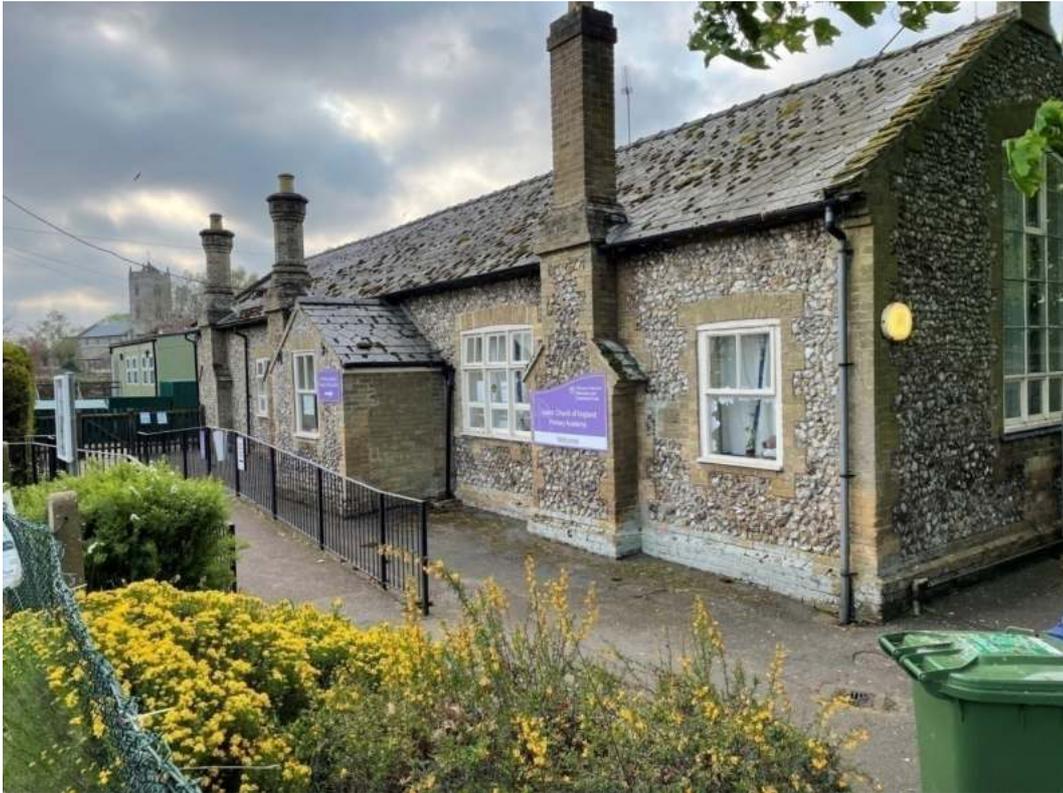
Figure 57: Gayton Church of England Primary Academy, Lynn Road, circa 1800's

**Description:** Brick and flint built main body of school with slate roof tiles. Distinctive single storey height building, with front porch and three tall chimney stacks. To the side and rear of main school are several nondescript portacabin buildings providing for overspill.

**Significance:** The current main School is considered a Landmark building and of architectural and aesthetic value whilst also being of local historic interest and association. The style, form and construction of the building is easily identifiable.

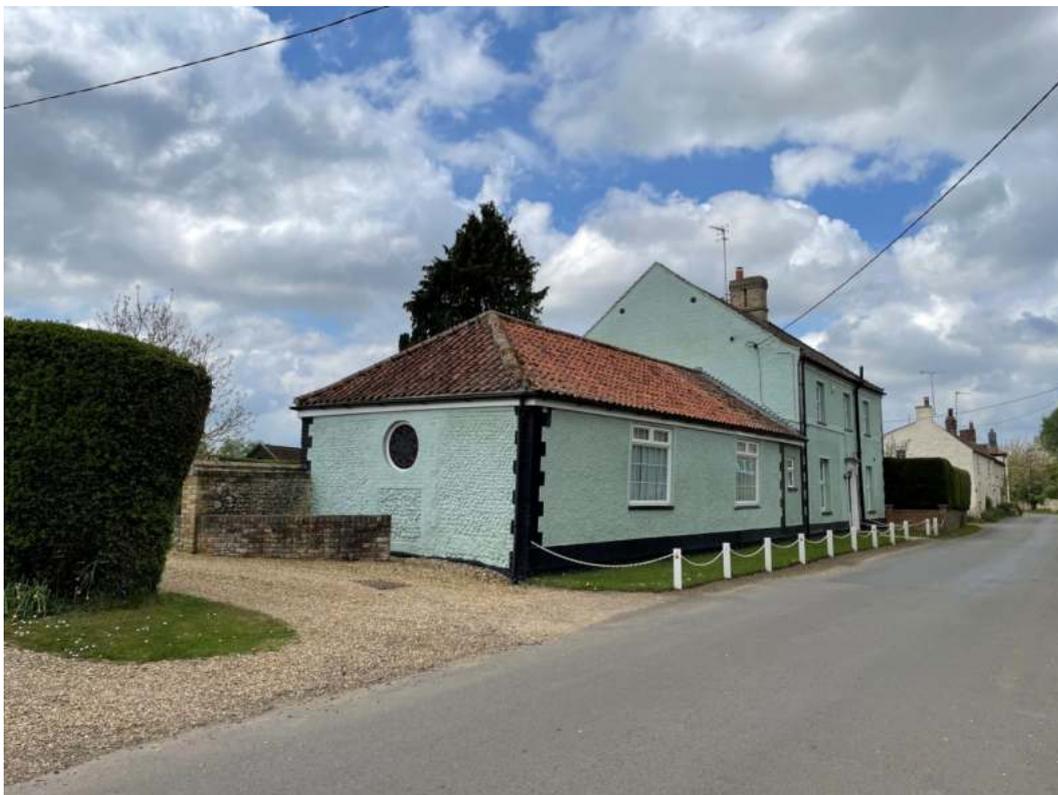
Figure 58: Lattice House, Back Street, circa 1750

**Description:** Main body is brick built and render, gable ends are flint and render, possible sub level in chalk and flint. The oldest part of the building is single storey, circa 1750 and had been a Chapel. The dwelling is now privately owned but historically was one of several Public Houses along Back Street.

**Significance:** Of local historic interest and association. It is a distinctive vernacular house contributing to the rural community of Back Street. The style form and construction of the building is easily identifiable.

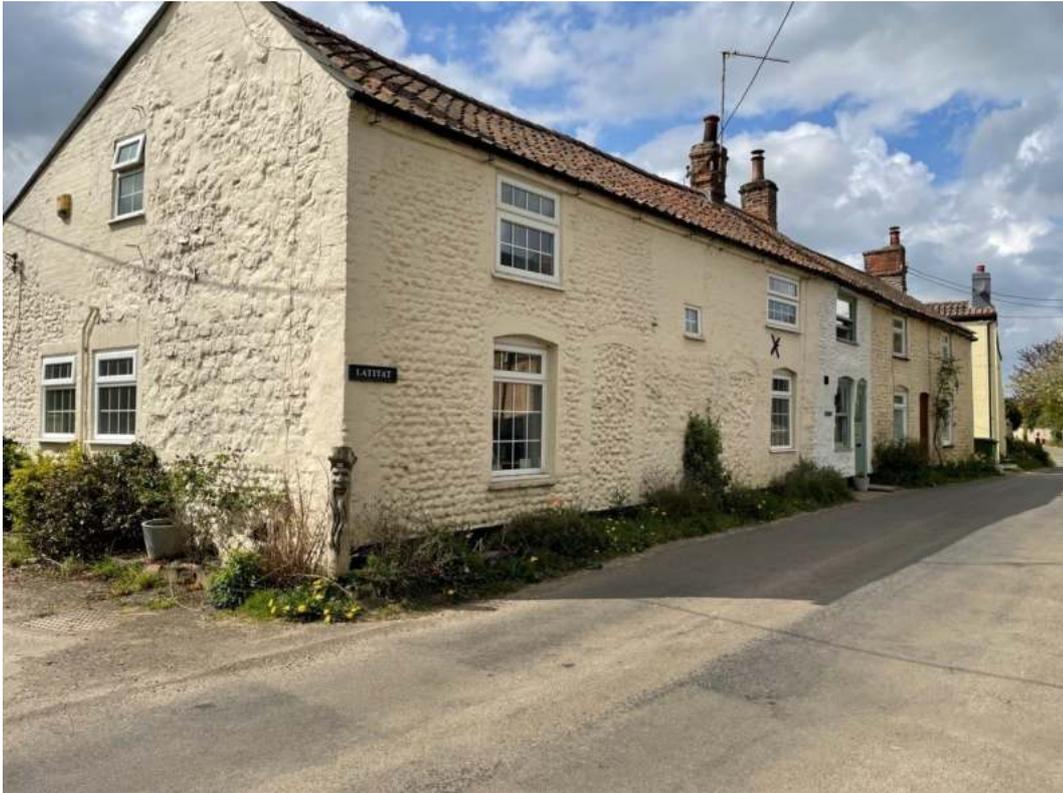
**Figure 59: Latitat Cottage to Sunshine Cottage, Back Street circa 1800's**

**Description:** Built of chalk and flint with brick additions and pantile roofs. Row of properties directly abut the road. Possible workers' cottages at one time. Sunshine Cottage circa 1700's is mainly render faced with later brick-built additions with modern windows to rear.

**Significance:** Of local historic interest. Although altered in parts, ie. entrances removed, extension added, the façade of the buildings remains attractive and its distinctive vernacular contributes to the rural setting of Back Street. The style, form and construction of the buildings is easily identifiable.

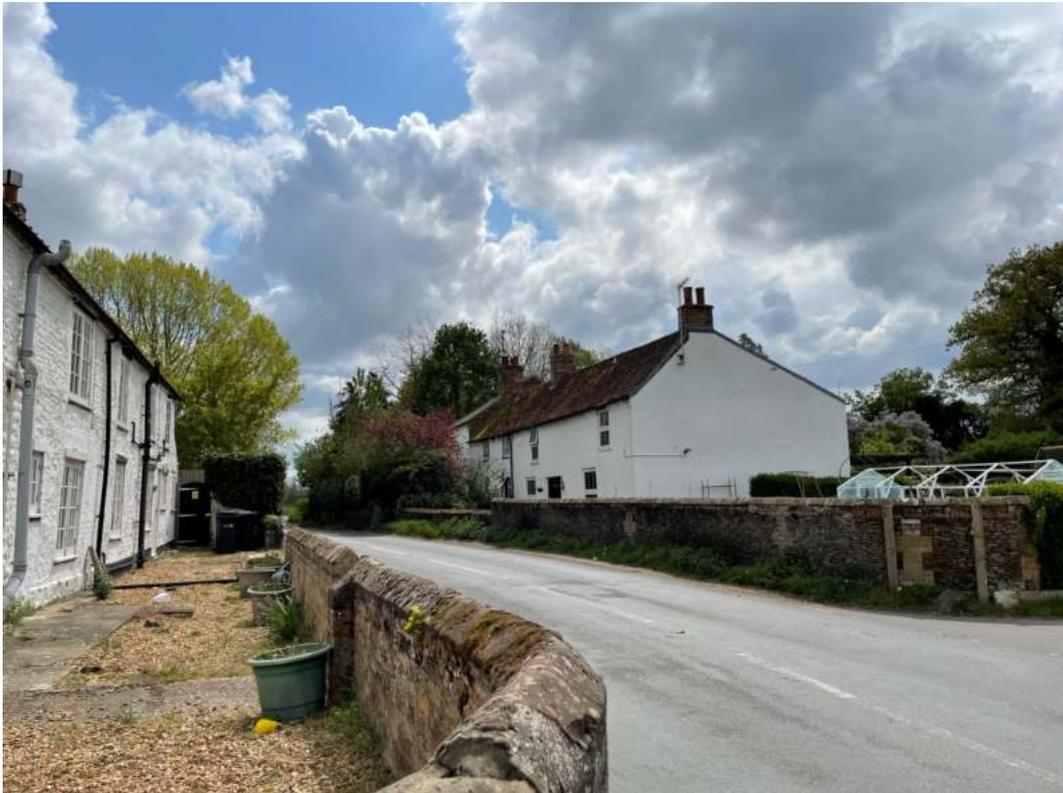
Figure 60: Cluster of Estate Cottages, East Walton Road and Back Street circa mid 1800's (B1153)

**Description:** White rendered brick and chalk dwellings with pantile roofs. Later addition of brick extension to rear of properties.

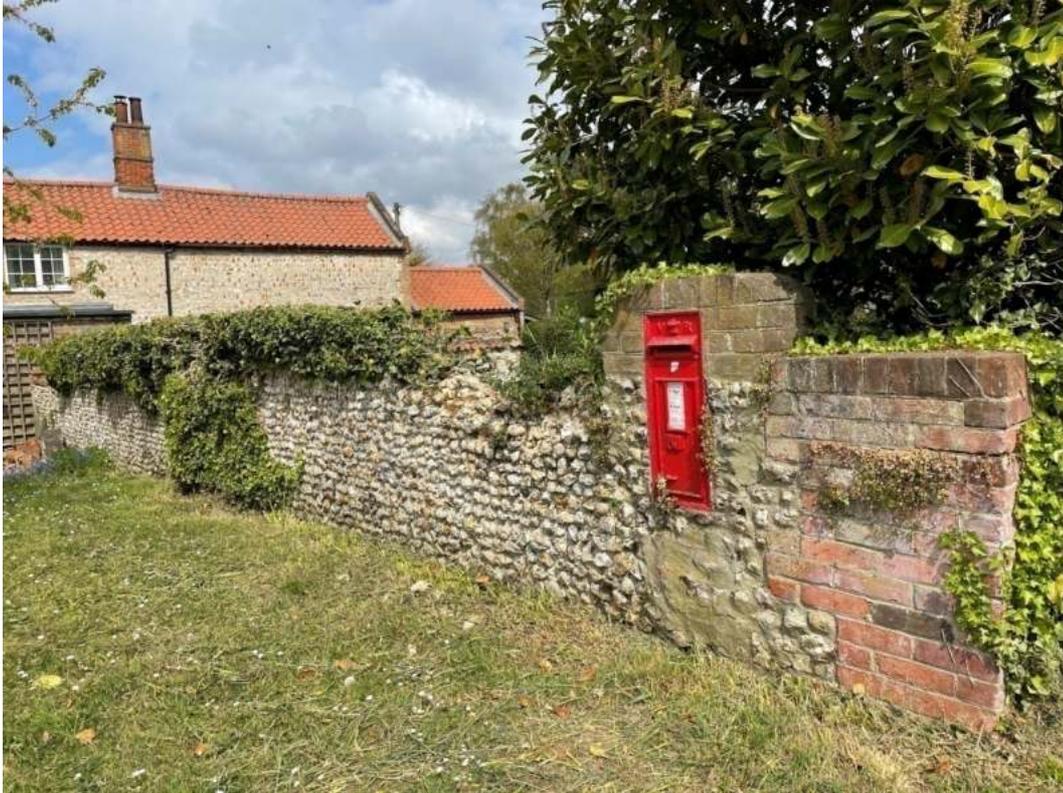
Figure 61: Antique Royal Mail Post Box inset into wall, junction of Lynn Road/B1145 and Grimston Road/B1153. Circa 1850's

**Description:** In service Royal Mail post box, with letters VR (Victoria Regina), signifying Queen Victoria was Monarch when it was installed.

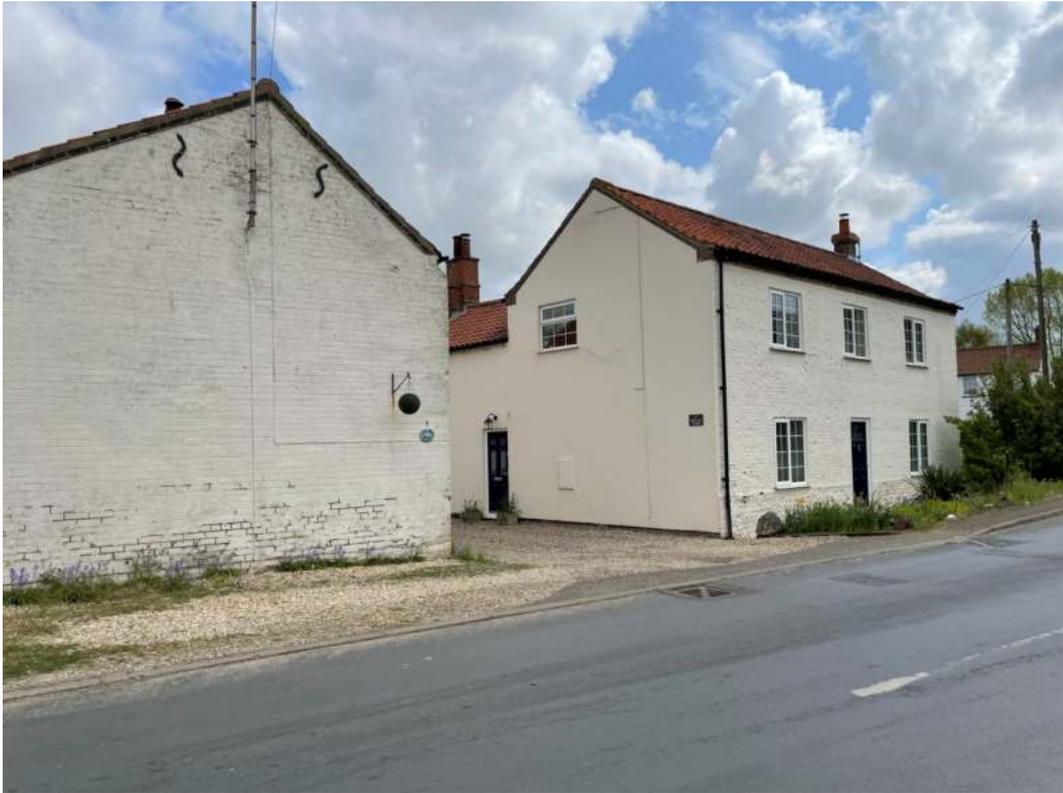
Figure 62: Mill End Cottages Numbers 1, 2 and 3, circa mid 1800's, Grimston Road

**Description:** Whitewashed brick and chalk construction artisan cottages, with pantile roofs and arranged around area of land to the rear.

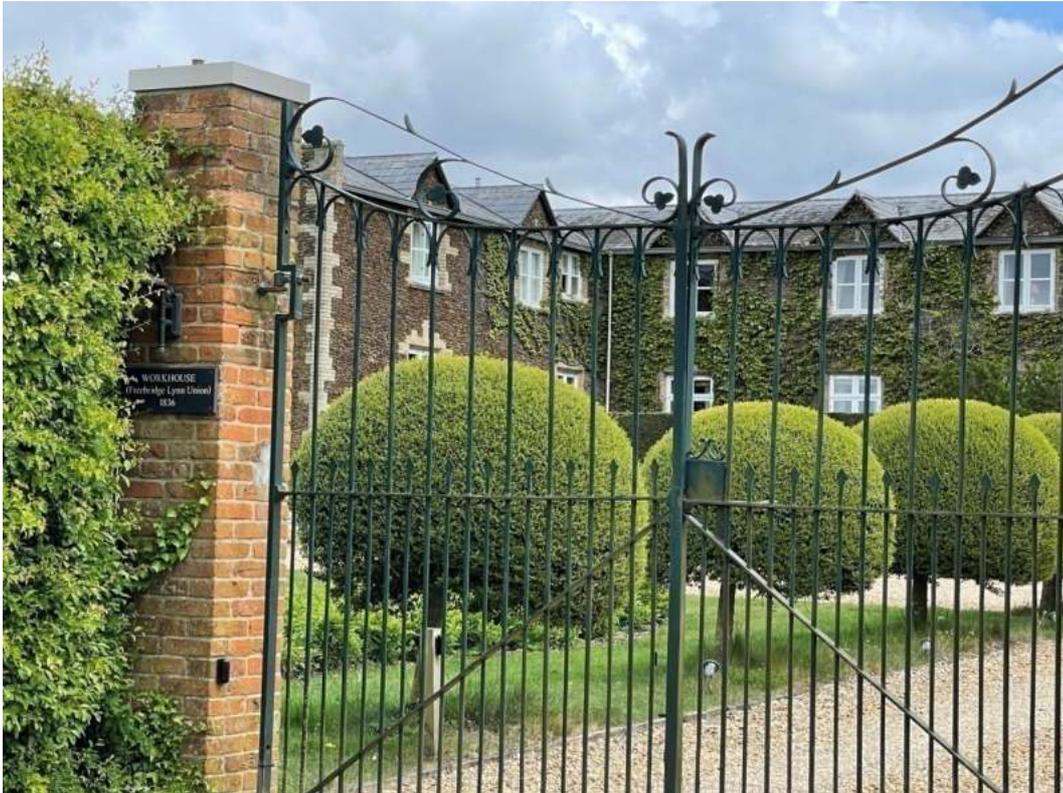
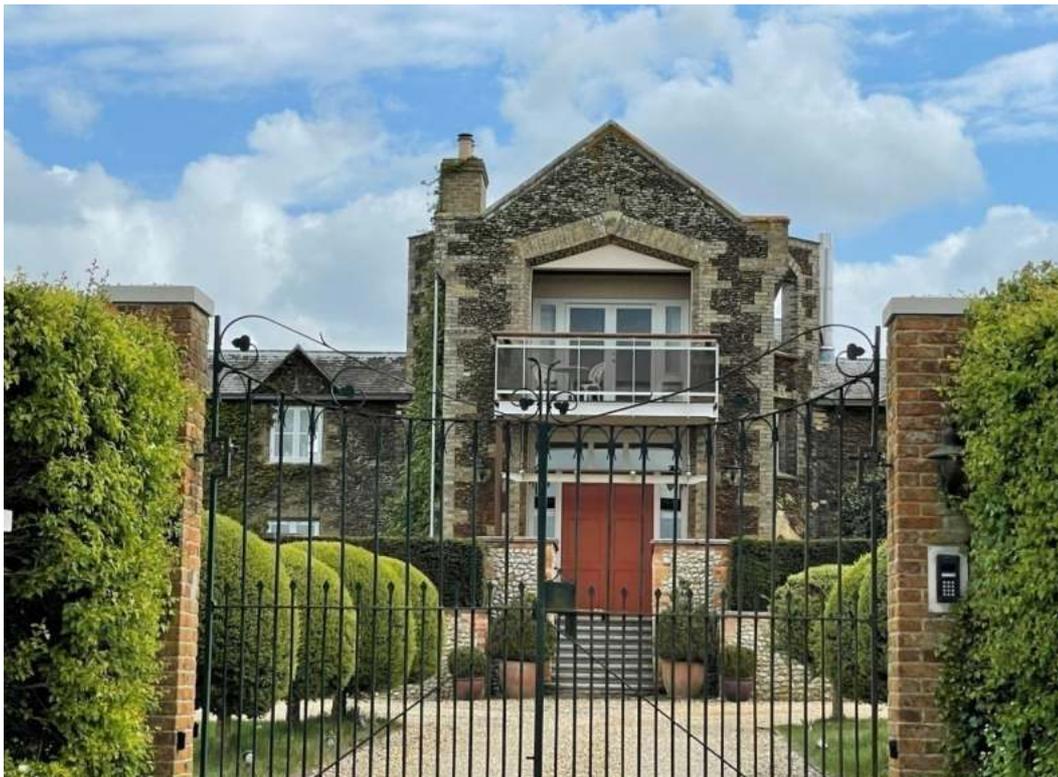
Figure 64: Eastgate House, Eastgate Drive, former Freebridge Lynn Union Workhouse, circa 1836, designed by Donthorne. North Wing.

**Description:** Substantial structure built of brick, carrstone and stone with slate tile roof, sited on an elevated position some miles from all community. Former Freebridge Lynn Union Workhouse. It later became an Old Peoples' Home 1948 – 1963. (Ref [www.heritage.norfolk.gov.uk](http://www.heritage.norfolk.gov.uk)). The property is now privately owned and has been sympathetically remodelled and split into several homes.
