# Gayton and Gayton Thorpe Neighbourhood Plan

## Appendix B

## Appendix B Non-Designated Heritage Assets

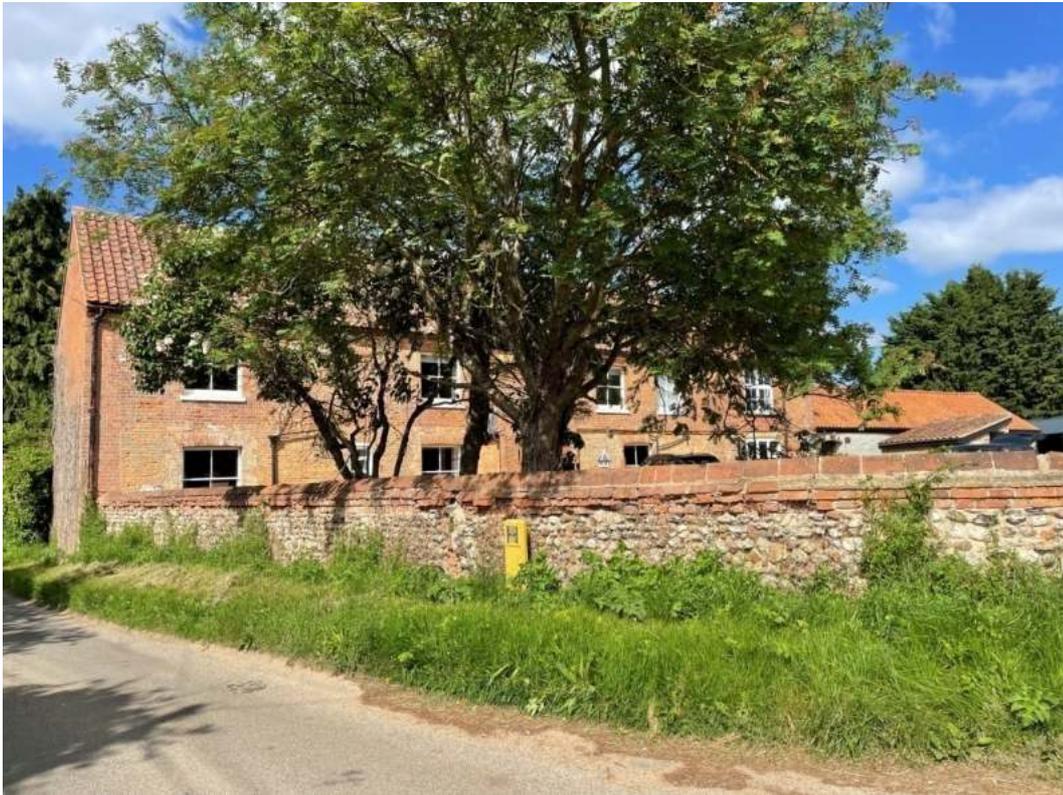
Figure 67: Manor Farm, Common Lane, circa late 1700's

**Description:** Large double fronted property built of red brick with pantile roof and attached barn also of brick with chalk and pantile roof. Sited at the western end of Common Lane behind a brick, flint and chalk boundary wall with wide and open access frontage to the main house.

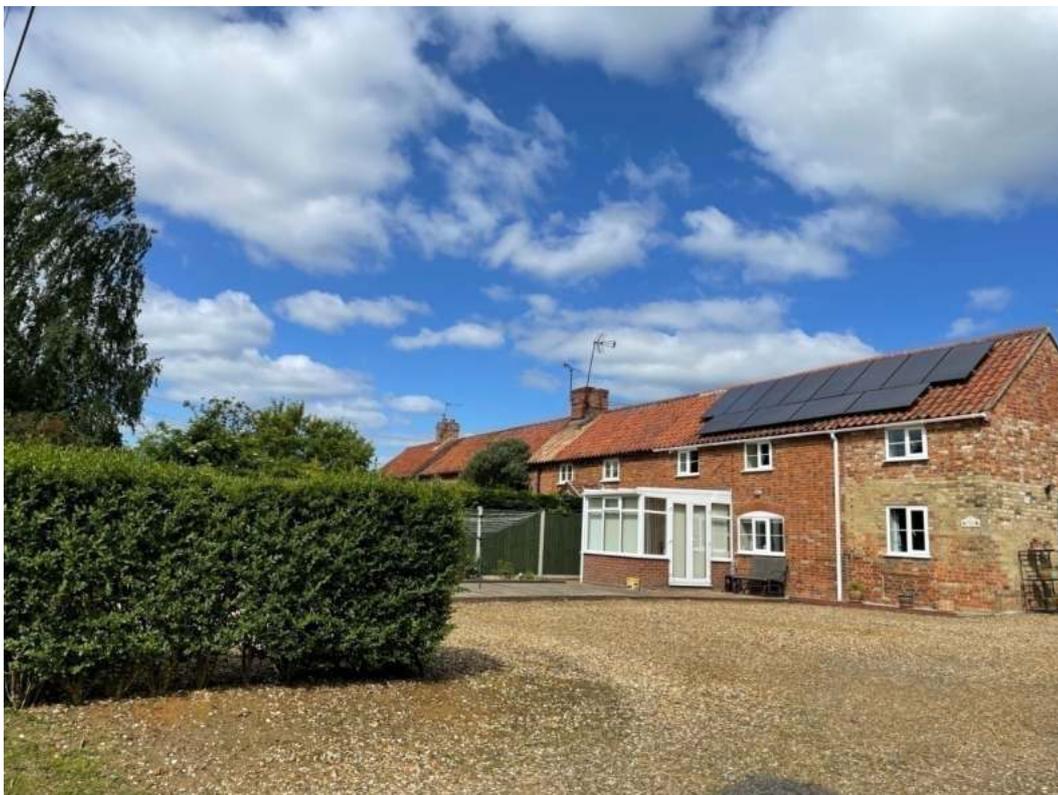
Figure 68: Well Yard Cottages, Common Lane, circa 1800's (Possible late 1700's)

**Description:** Originally terrace of four Estate cottages built from red brick with pantile roof, all with small casement windows.

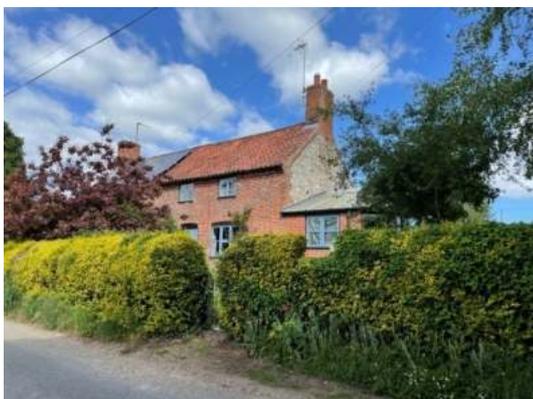
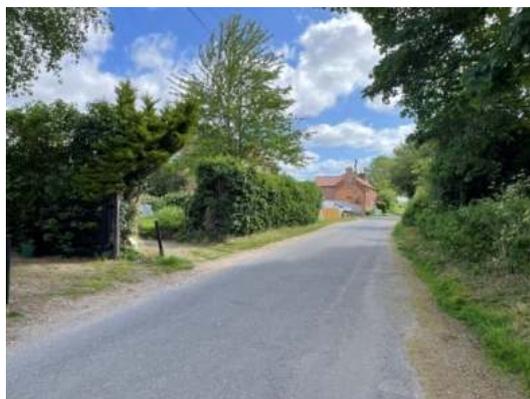
Figure 69: Semi-detached workers cottage - example

Figure 70: Row of 4 pair semi-detached workers cottages

**Description:** Originally built as Estate farm cottages from locally sourced red brick, with A-frame roofs forming the upper storey and with flint and chalk gable ends and pantile roofs.

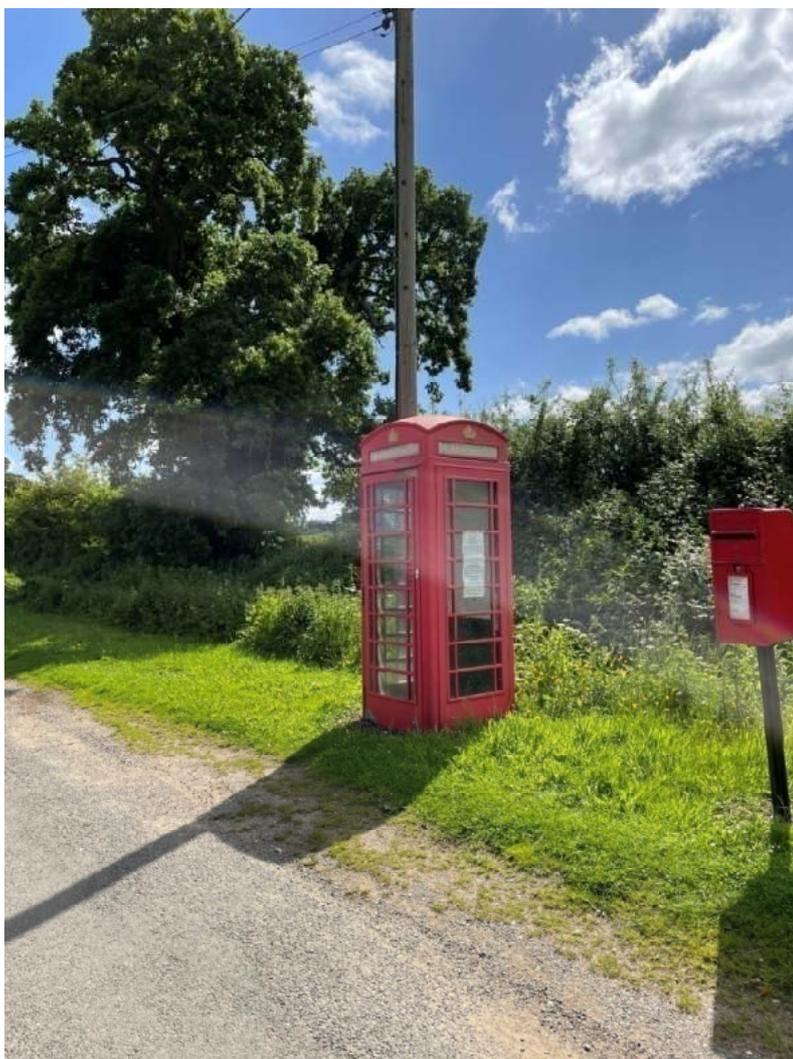
#### 28. Red GPO Telephone Box circa early 1900's

**Description:** Red GPO Telephone box, now out of service. Known as the K2 model, made of cast iron and designed by Sir Giles Gilbert Scott. The colour red was used to make them easy to spot. From 1926, the fascias of the kiosks were emblazoned with a prominent crown, representing the British Government. In 2006 the K2 telephone box was voted one of the top 10 British design icons.

**Significance:** Of local historic interest. The style form and construction of the Telephone box, often seen as representing a British cultural icon, is easily identifiable.

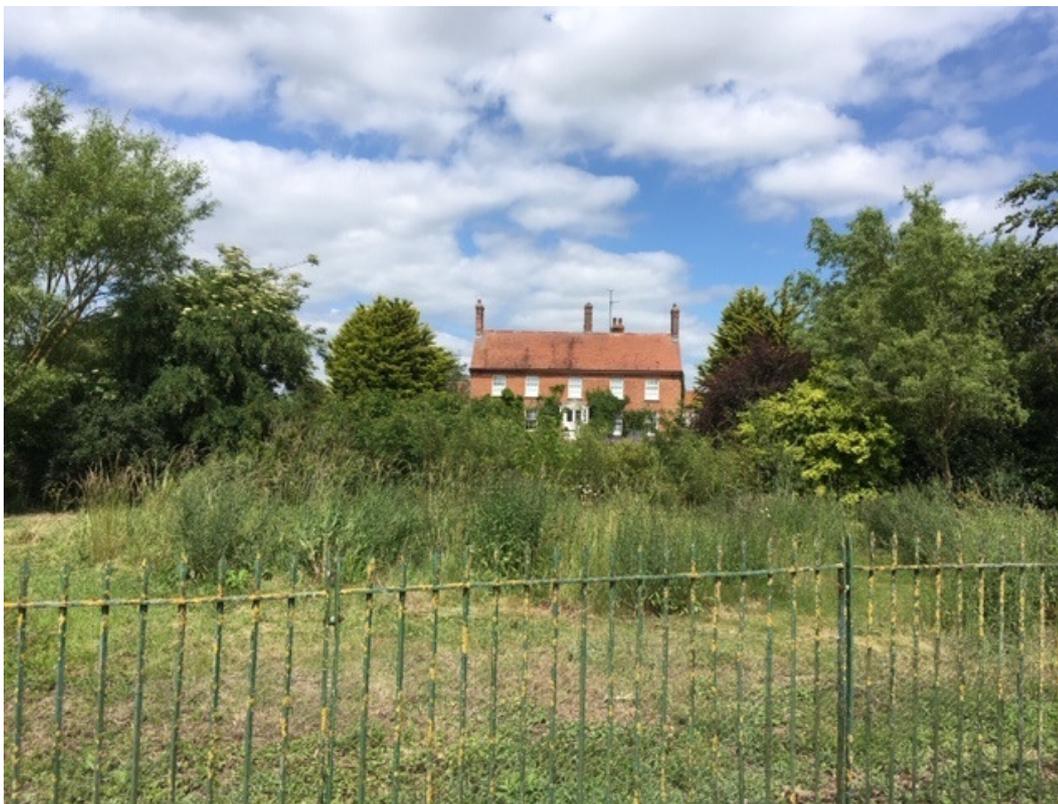
### 29. Great Barn Farmhouse – Old Norwich Road circa 1700's to 1830's

**Description:** Large farmhouse built of red brick and pantile roof, erected during the Georgian period when trade expanded along with consumerism and popular culture blossoming. This house is a beautiful representation of a Georgian property, being double fronted with many sash windows bringing balance to its façade. There appear to be some later additions, such as the porch which opens onto a small patio leading to the lawns.

It is set in abundant land and is close to converted farm buildings comprising, the stable, piggery and tack room. One of the most important listed buildings in Gayton Thorpe is attached to this Farmhouse and is known as The Great Barn.
